The City of Calgary

# RIPARIAN MONITORING PROGRAM PHASE 2 FINAL PROGRAM REPORT

Final Report  
December 14, 2023  
KWL Project No. 810.090.300

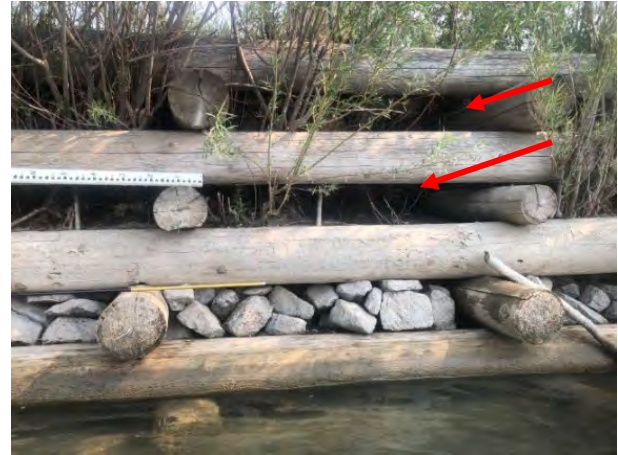
**Photo 3-9: Example of backfill material washout in a timber crib wall installed on the Bow River in 2015 and assessed in 2021**

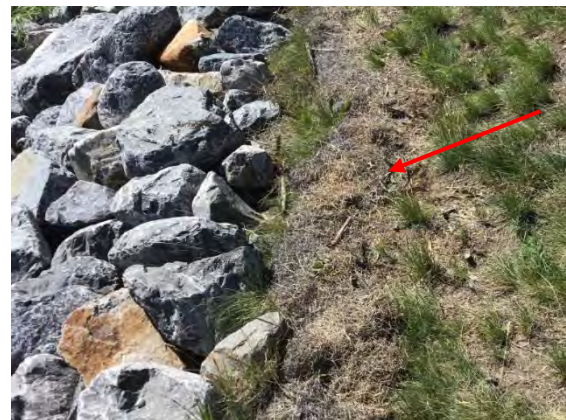
**Photo 3-13: Example of biodegradable wattle (Curlex® Sediment Log®) at an advanced state of decomposition installed on the Elbow River in 2015 and assessed in 2018**

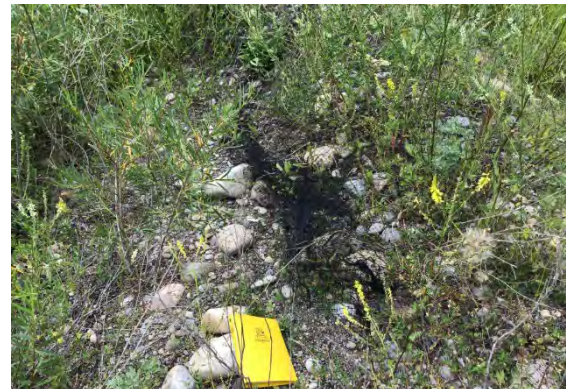
Photo 3-15: Example of the remains of synthetic erosion control matting that was installed in 2008 and observed in 2020

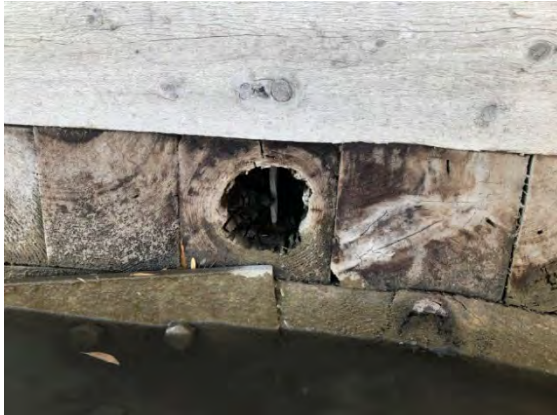
**Photo 3-18: Standard grade cedar timber with dry rot used in the timber crib wall**

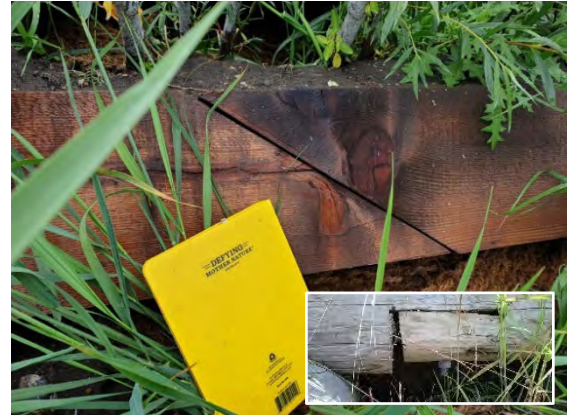
**Photo 3-19: Transverse connections between timbers used in the timber crib wall (inset: notched connection for comparison)**

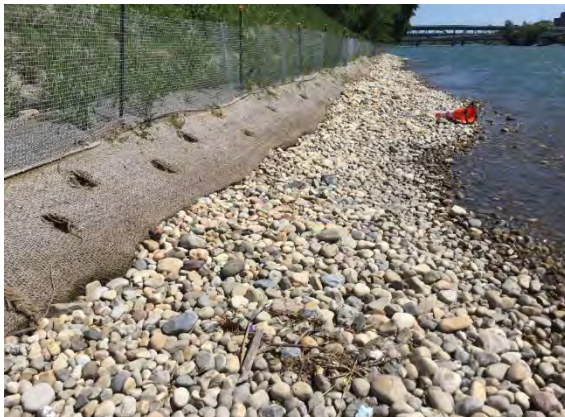
**Photo 3-20: Example of riprap covered with river gravels on the Bow River**

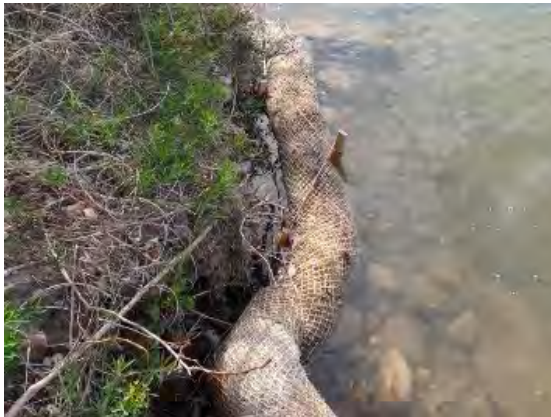
Photo 3-24: Floating wattles at site on the Bow River

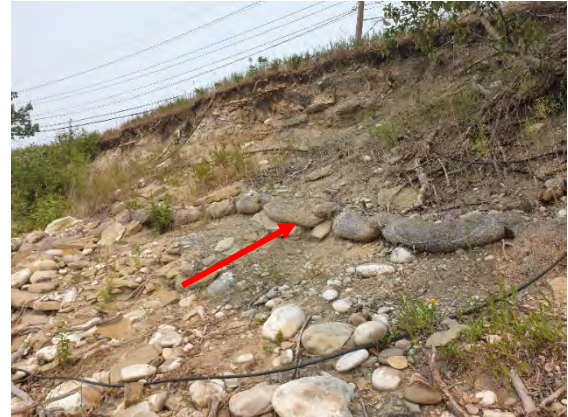
Photo 3-25: Wattle installed improperly and in poor condition on slope with surface erosion

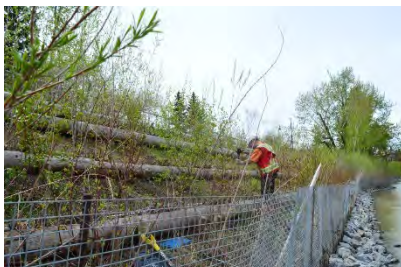
**Photo 3-35: Recently browsed site on May 25, 2020**

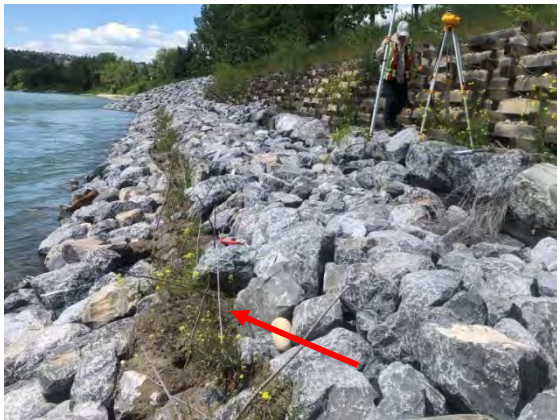
**Photo 3-38: Example of a site with challenging growing conditions due to sun exposure on a large riprap toe**

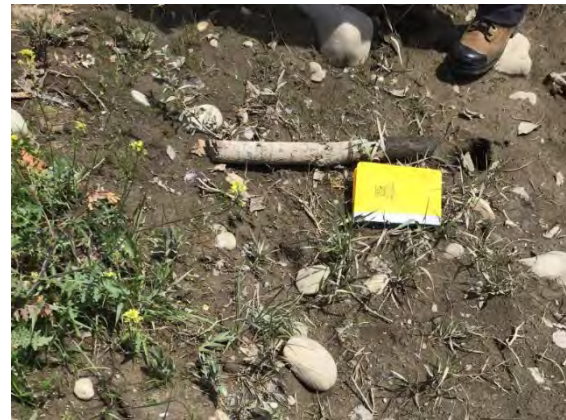
**Photo 3-39: Example of shallow burial and mortality of a live cutting**

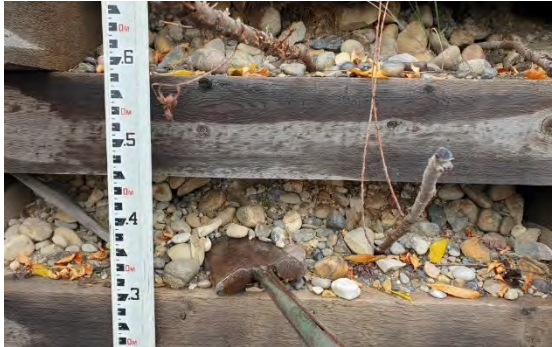
**Photo 3-42: Example of dead live cuttings installed on the Bow River in 2016 and assessed in 2019**

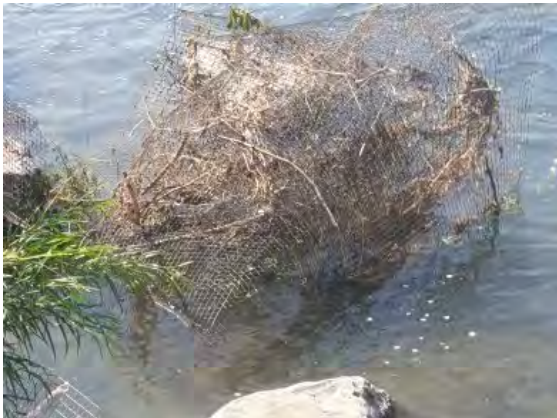
**Photo 3-54: Temporary browsing protection fencing to be removed due to hazard to wildlife and the public**

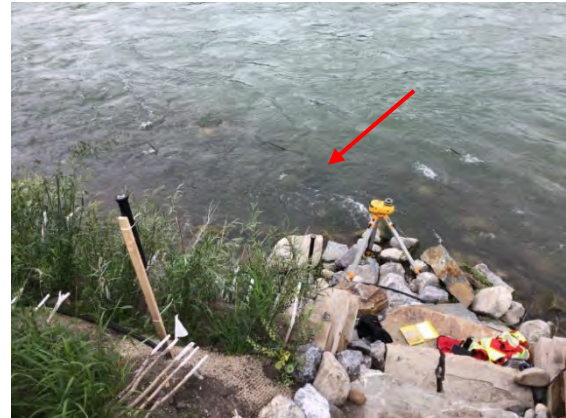
**Photo 3-55: Submerged temporary browsing protection fencing in need of repair**

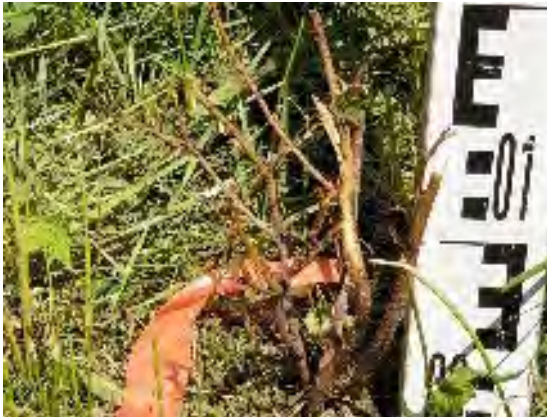
Photo 3-56: Weed wacker damage to Year 1 age class prickly rose in summer 2019

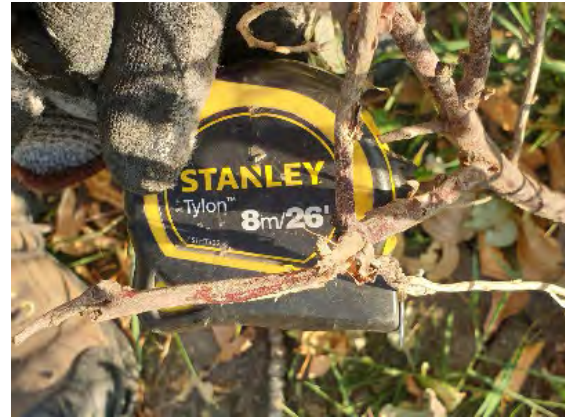
Photo 3-57: Weed whacker damage to Year 1 age class saskatoon in Fall 2020

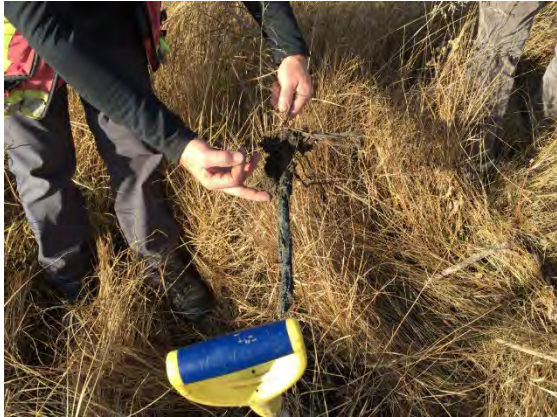
**Photo 3-58: Live cutting planted in anaerobic soil at a site on West Nose Creek**

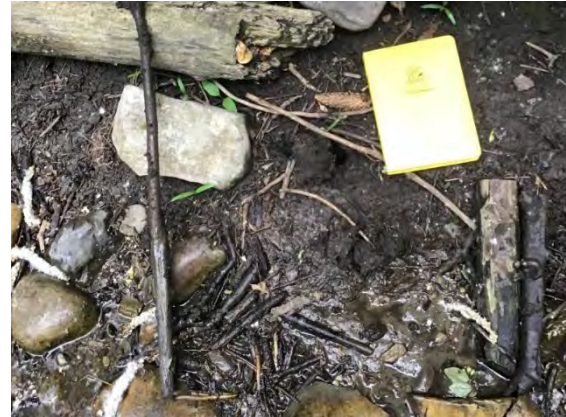
**Photo 3-59: Live cutting planted in anaerobic soil at a site on Shaganappi Creek**
