The City of Calgary

RIPARIAN MONITORING PROGRAM PHASE 2 FINAL PROGRAM REPORT

Final Report
December 14, 2023
KWL Project No. 810.090.300

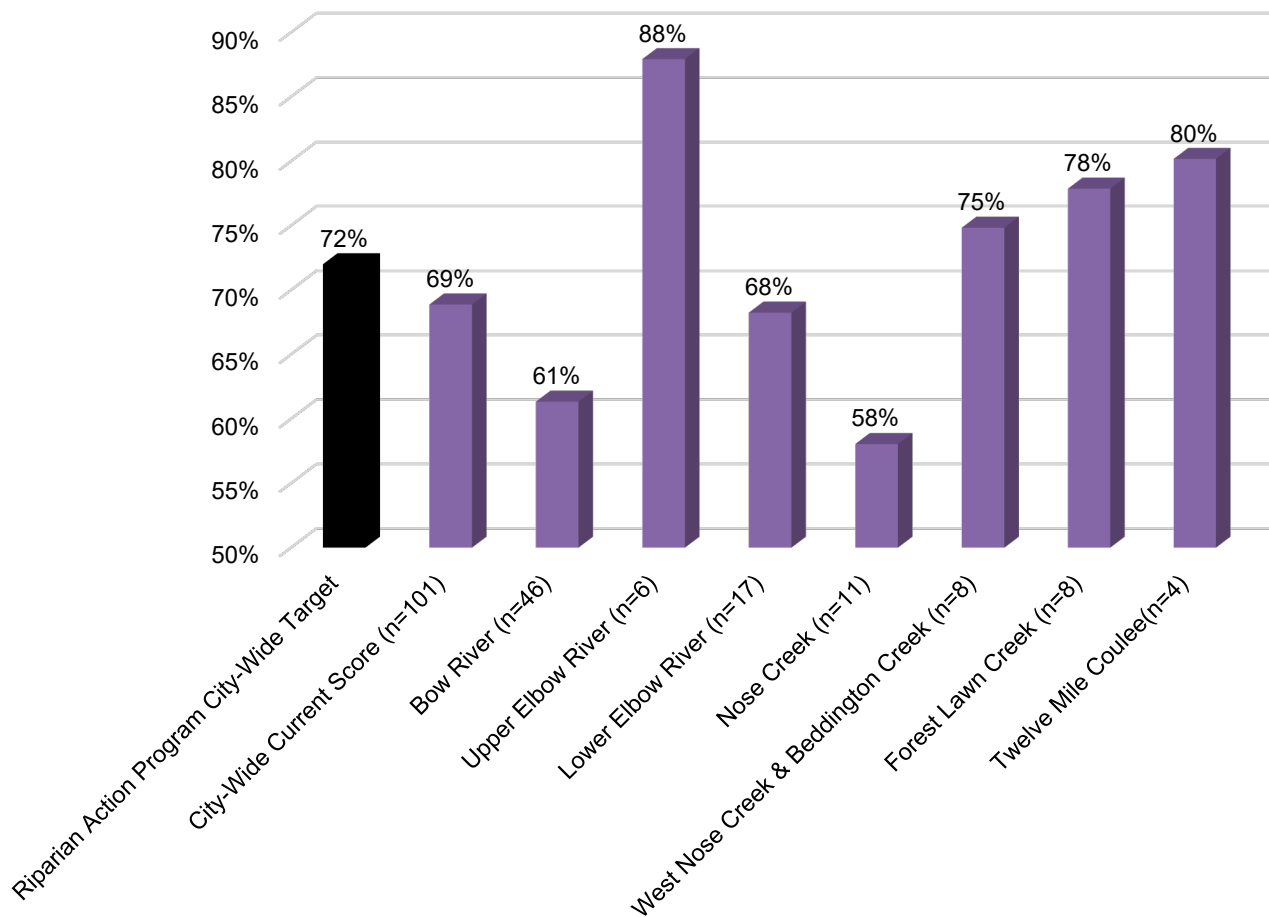
From 2014 onward and during Phase 2 of the RMP, the trend monitoring program expanded from 58 sites to 101 sites city-wide², resulting in a **current city-wide riparian health score of approximately 69%** (*healthy, with problems*)³. Figure 1 below shows the results for the expanded project area in comparison to baseline. The highest rated riparian sites were located along the southeast fringe for the Bow River and in Weaselhead Flats and Clearwater Legacy Parks for the Elbow River.

Figure 1: City-Wide Current Score Summary by Waterbody (n=101 sites, 84 km of bank length; 590.5 ha of habitat)

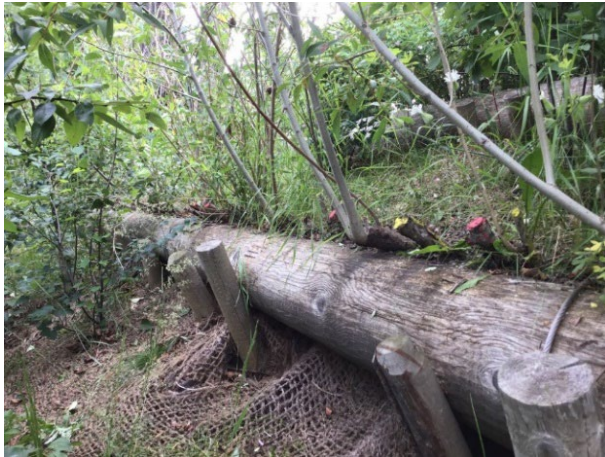
**Photo 1: Bank Effectiveness Highest Rated Site:
Riverdale Avenue Retaining Wall Replacement
Phase 2 – Downstream (July 21, 2020)**

Many sites were observed with outstanding vegetation establishment and growth across the city that will serve as benchmarks for future bioengineering and riparian planting projects. **The highest-rated site was the Riverdale Avenue Retaining Wall Replacement Phase 2 – Downstream on the Elbow River** (see Photo 3 Photo 2 below).

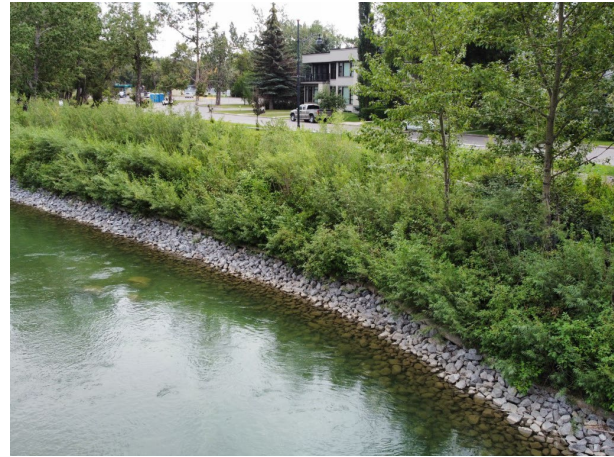
**Photo 2: Bank Effectiveness Highest Rated Site:
Riverdale Avenue Retaining Wall Replacement
Phase 2 – Downstream (July 25, 2022)**

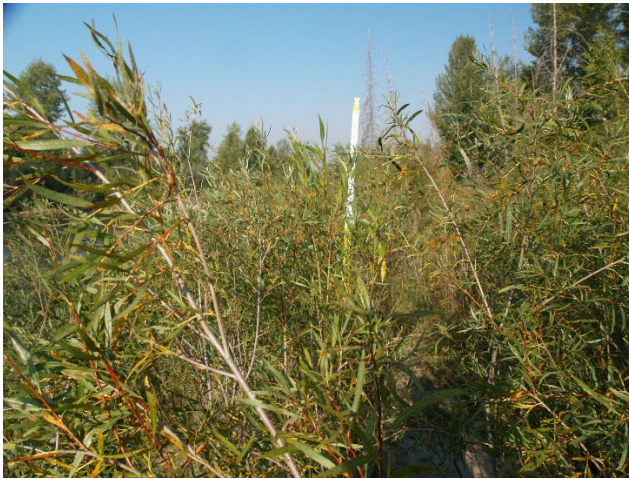
received the **highest overall rating** among all riparian monitoring sites, with success factors including good planting design and appropriate native species selection.

Photo 3: Riparian Effectiveness Highest Rated Site: Griffiths Woods – RBC and Other Plantings site (2018)

The overall scores for the sites ranged from Poor to Good, with maintenance, implementation, and BRQI ratings often scoring lower. **Griffiths Woods – RBC and Other Plantings** site (see Photo 3 and Photo 4 below)

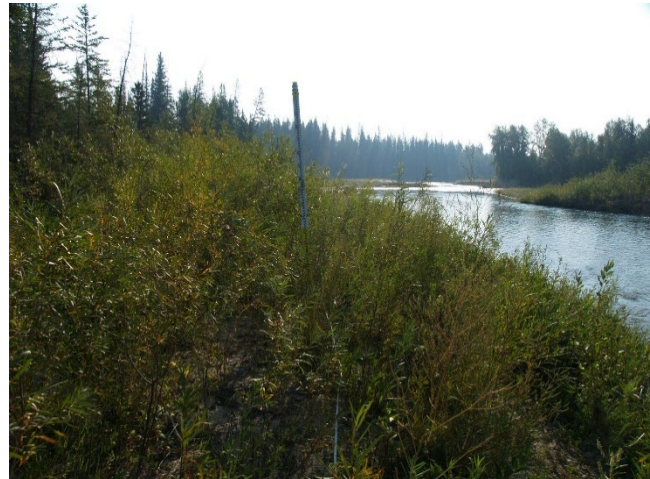
Photo 4: Riparian Effectiveness Highest Rated Site: Griffiths Woods – RBC and Other Plantings site (2018)
