The City of Calgary

RIPARIAN MONITORING PROGRAM PHASE 2 FINAL PROGRAM REPORT

Final Report
December 14, 2023
KWL Project No. 810.090.300

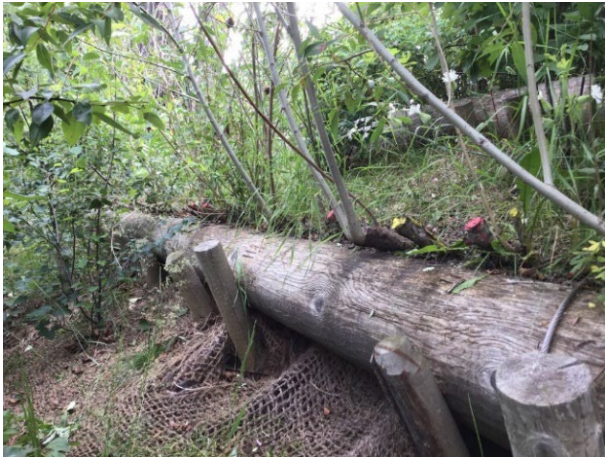
Many sites were observed with outstanding vegetation establishment and growth across the city that will serve as benchmarks for future bioengineering and riparian planting projects. **The highest-rated site was the Riverdale Avenue Retaining Wall Replacement Phase 2 – Downstream on the Elbow River** (see Photo 1 and Photo 2 below).

**Photo 1: Bank Effectiveness Highest Rated Site:
Riverdale Avenue Retaining Wall Replacement
Phase 2 – Downstream (July 21, 2020)**

- Many sites were observed to have outstanding vegetation establishment and growth across the City that will serve as benchmarks for future bioengineering and riparian planting projects. The Riverdale Avenue Retaining Wall Replacement Phase 2 – Downstream (Age Class: Year 1, Typology: Vegetated Crib Wall) on the Elbow River was identified as the highest rated bank effectiveness site and is featured in Box 11 in the main report. The Griffiths Woods – RBC and Other Plantings site (Age Class: Year 1, Typology: Native Tree and Shrub Plantings) on the Elbow River was the highest rated riparian effectiveness site and is shown in Box 12 in the main report.

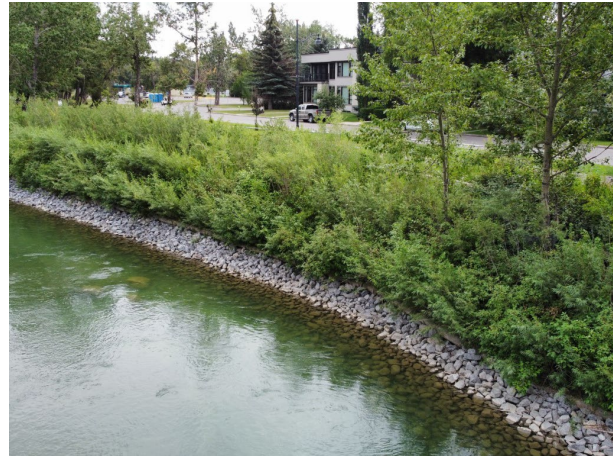
**Photo 2: Bank Effectiveness Highest Rated Site:
Riverdale Avenue Retaining Wall Replacement
Phase 2 – Downstream (July 25, 2022)**

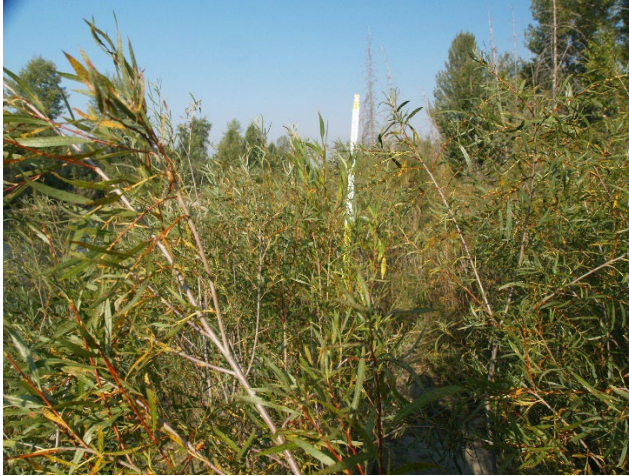
Photo 3: Riparian Effectiveness Highest Rated Site: Griffiths Woods – RBC and Other Plantings site (2018)

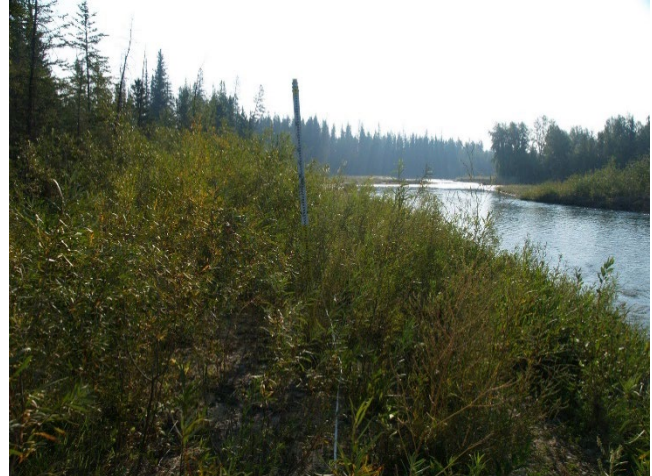
Photo 4: Riparian Effectiveness Highest Rated Site: Griffiths Woods – RBC and Other Plantings site (2018)
