The City of Calgary

# RIPARIAN MONITORING PROGRAM PHASE 2 FINAL PROGRAM REPORT

Final Report  
December 14, 2023  
KWL Project No. 810.090.300

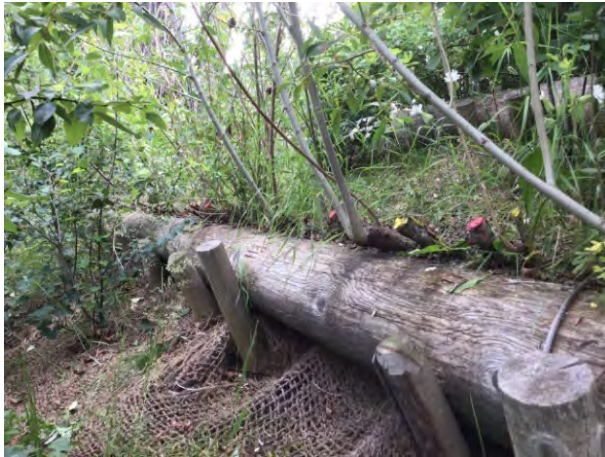
Many sites were observed with outstanding vegetation establishment and growth across the city that will serve as benchmarks for future bioengineering and riparian planting projects. **The highest-rated site was the Riverdale Avenue Retaining Wall Replacement Phase 2 – Downstream on the Elbow River** (see Photo 3 Photo 2 below).

Photo 1: Bank Effectiveness Highest Rated Site:  
Riverdale Avenue Retaining Wall Replacement  
Phase 2 – Downstream (July 21, 2020)

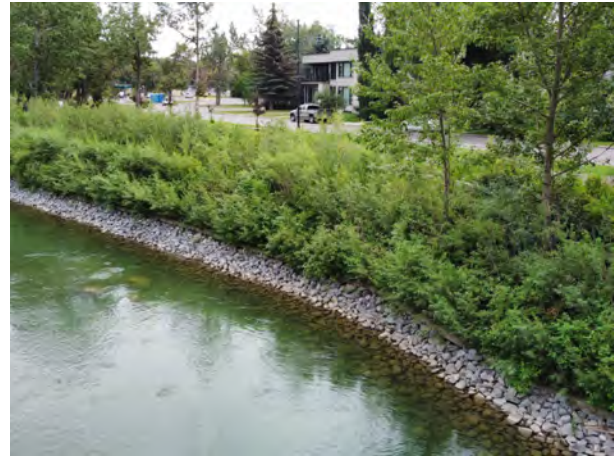
Photo 2: Bank Effectiveness Highest Rated Site:  
Riverdale Avenue Retaining Wall Replacement  
Phase 2 – Downstream (July 25, 2022)

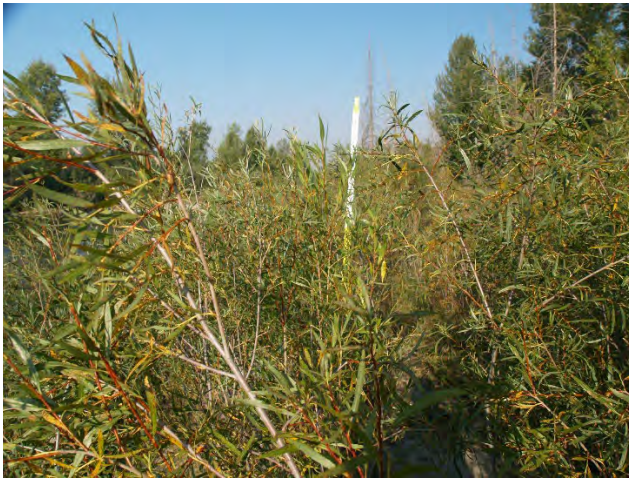
The overall scores for the sites ranged from Poor to Good, with maintenance, implementation, and BRQI ratings often scoring lower. **Griffiths Woods – RBC and Other Plantings** site (see Photo 3 and Photo 4 below)

received the highest overall rating among all riparian monitoring sites, with success factors including good planting design and appropriate native species selection.

**Photo 3: Riparian Effectiveness Highest Rated Site: Griffiths Woods – RBC and Other Plantings site (2018)**

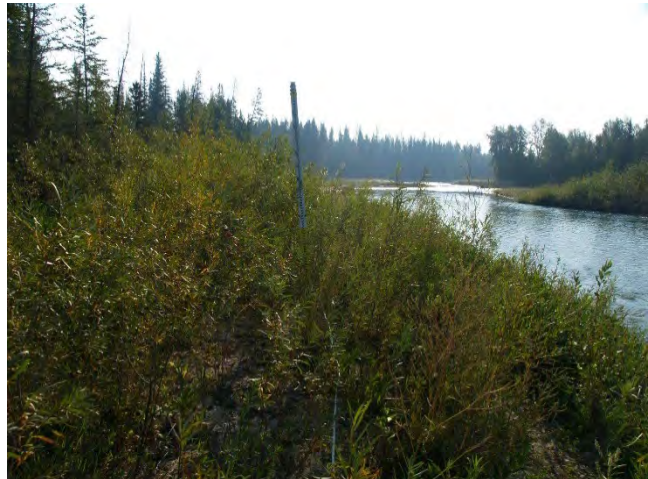
**Photo 4: Riparian Effectiveness Highest Rated Site: Griffiths Woods – RBC and Other Plantings site (2018)**

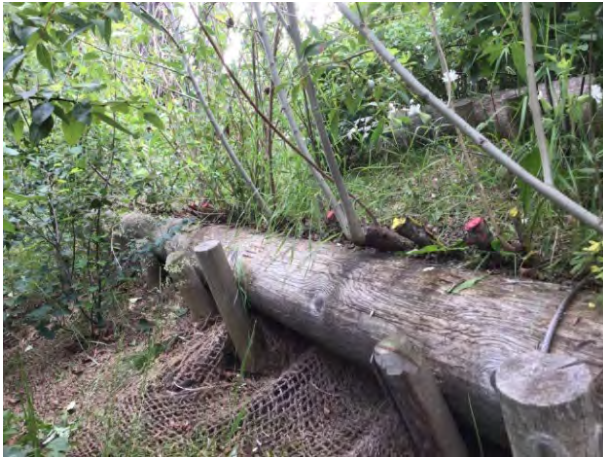
Many sites were observed with outstanding vegetation establishment and growth across the city that will serve as benchmarks for future bioengineering and riparian planting projects. **The highest-rated site was the Riverdale Avenue Retaining Wall Replacement Phase 2 – Downstream on the Elbow River** (see Photo 1 and Photo 2 below).

**Photo 1: Bank Effectiveness Highest Rated Site:  
Riverdale Avenue Retaining Wall Replacement  
Phase 2 – Downstream (July 21, 2020)**

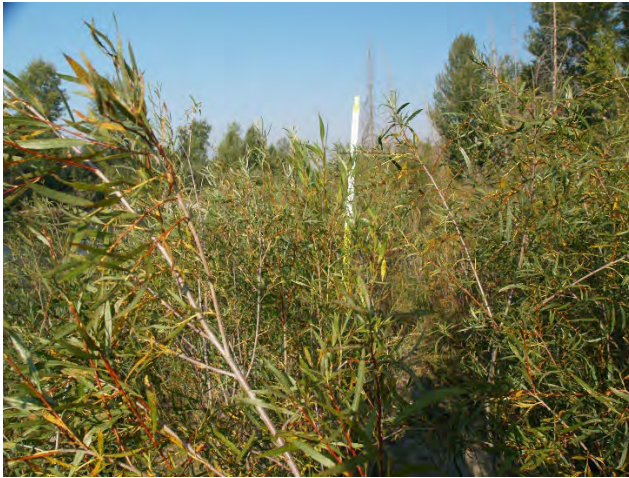
Average overall rating of the 57 assessments completed over the course of the program was 55 out of 100 (Fair), indicating moderate overall success. Generally speaking, riparian effectiveness sites scored well for design ratings, but suffered with low implementation and maintenance ratings. The highest rated site was **Griffiths Woods – RBC and Other Plantings** site (see Photo 3 and Photo 4 below).

**Photo 3: Riparian Effectiveness Highest Rated Site: Griffiths Woods – RBC and Other Plantings site (2018)**

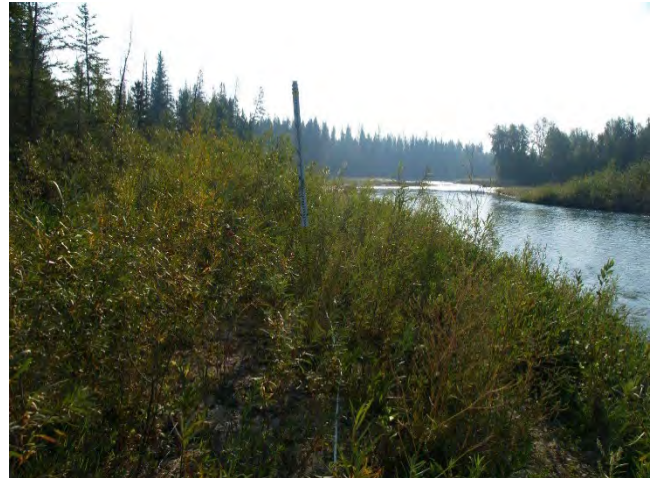
**Photo 4: Riparian Effectiveness Highest Rated Site: Griffiths Woods – RBC and Other Plantings site (2018)**

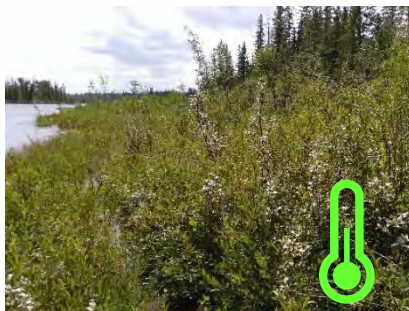
(Image no. RHIP30ELB072)

**Weaselhead Flats Park (ELB30)**  
Conservation Zone

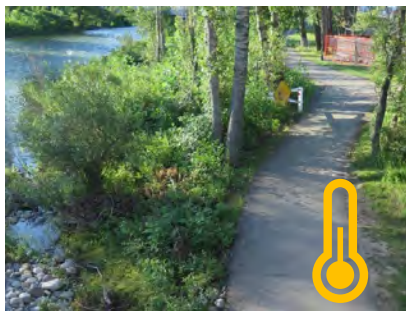
(Image no. RHIP26ELB30)

**Lindsay Park (ELB26)**  
Mixed Recreation/Conservation Zone

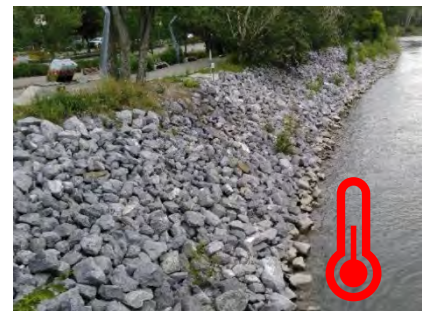
(Image no. RHIP49BOW067)

**Bow River, Sunnyside (BOW49)**  
Flood and Erosion Control Zone

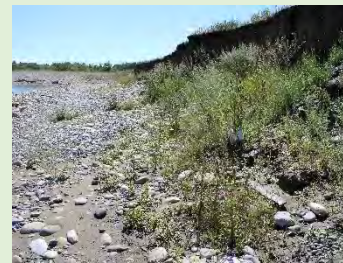
**2015:** A large depositional area formed during the 2013 flood at the base of the BOW91 bank (Inglewood Northfield). (Image no. RHIP91BOW024).

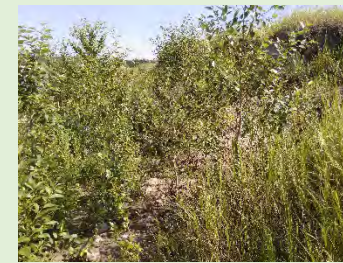
**2020:** This is one of many examples of a flush of poplar regeneration stimulated by the 2013 flood. (Image no. RHIP91BOW059).

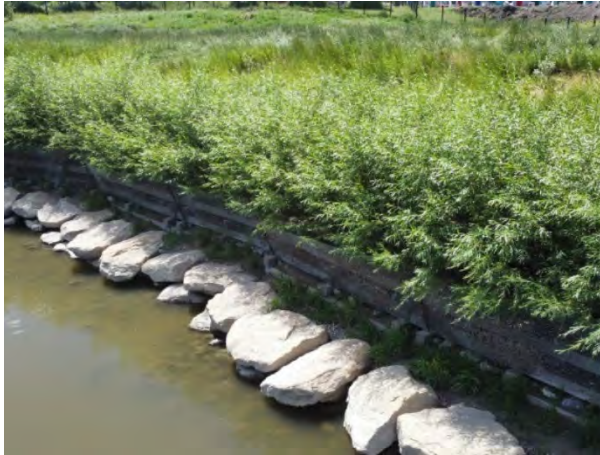
In general, most monitoring sites were observed to be stable with little to no erosion occurring within, upstream or downstream of the site, an example of which is shown in Photo 3-8. For the revisit sites, there was little to no change since the first assessments. However, there were a minority of sites that were observed to have specific instances of erosion, undermining, slope raveling, and backfill material washout per the example shown in Photo 3-9. Often, the key reasons for the observed issues were that the materials selected prematurely degraded or the design approach were not suitable to resist the erosive forces.

**Photo 3-8: Example of stable site with a vegetated timber crib wall installed on Nose Creek in 2021 and assessed in 2022**

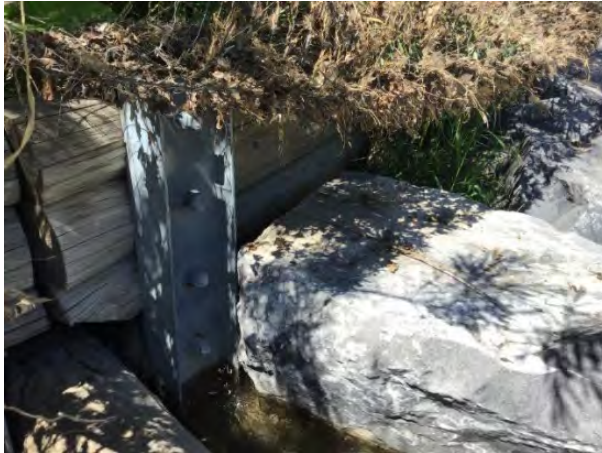
In general, the permanent materials selected for the structural components of the monitoring sites are fit-for-purpose and in good to very good condition. Rock, timber, steel, and concrete materials were found to be present according to the design of the sites and in good to excellent condition. An example of the permanent materials assessed is shown in Photo 3-10. The condition of gabion baskets and mattresses was variable, with those installed in areas with consistent exposure to stream flow in worse condition than those exposed infrequently.

**Photo 3-10: Example of site with riprap, timber and steel components installed on the Elbow River in 2015 and assessed in 2022**

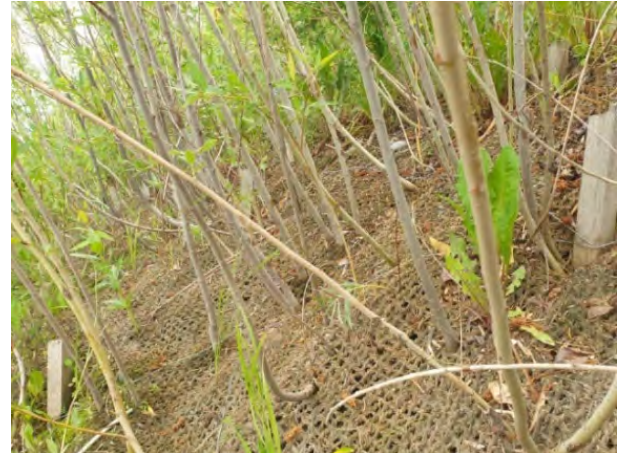
Temporary structural materials are intended to provide short- to medium-term stability at a site so that vegetation can establish and take over the long-term stability function. Common examples of temporary structural materials are erosion control matting, coir geogrid, hydromulch, and wattles. The condition and application of temporary structural materials was variable. When installed correctly, these products appeared to be functioning as intended per the example of the biodegradable coir geogrid shown in Photo 3-11. However, in some cases, they were not used for the appropriate application (e.g., erosion control matting used as material containment in timber crib walls alone instead combining with a coir geogrid) or were not installed properly (e.g., wattles installed vertically instead of on contour) and were not effective as implemented as they were not providing site stability for vegetation establishment.

**Photo 3-11: Example of biodegradable coir geogrid installed at a site on Bow River in 2017 and assessed in 2019 and 2021**

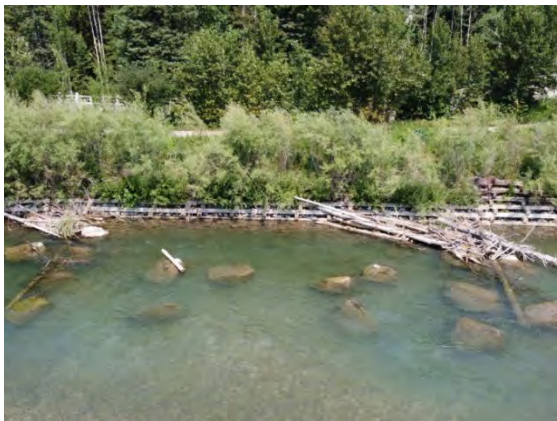
Fish structures such as instream boulders have been included in several sites and appeared to be providing good quality habitat by way of hydraulic diversity and in-stream cover for fish (Photo 3-16). Woody debris was also observed to be incorporated into and naturally recruited onto structures (Photo 3-17). When located on the bank, this woody debris supports moisture retention at the site, contributes organic material to the soil as it degrades, and promotes habitat for wildlife. When it is located in-stream along the toe of the structure, it provides fish and wildlife habitat. Overhanging vegetation was observed at several sites and is providing good overhead shade, cover, and organic debris input for fish habitat, and assisting the reduction of water temperatures. The overhanging cover was measured to be in the range of 2 to 3 m at several sites (Photo 3-17).

Photo 3-16: Example of fish habitat enhancement boulders and woody debris at a timber crib wall site on the Elbow River assessed in 2019 and 2021

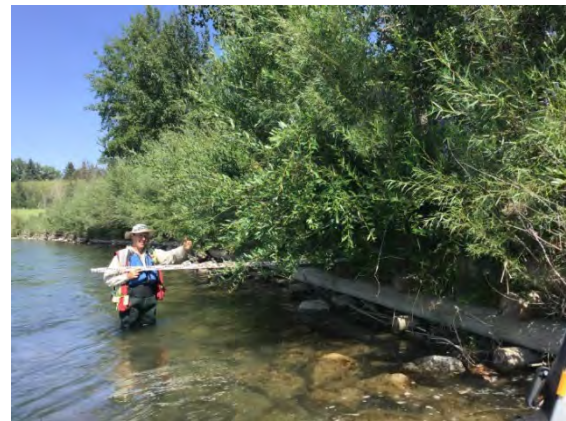
Photo 3-17: Example of overhanging vegetation at a timber crib wall site on the Bow River that was assessed in 2018 and 2022

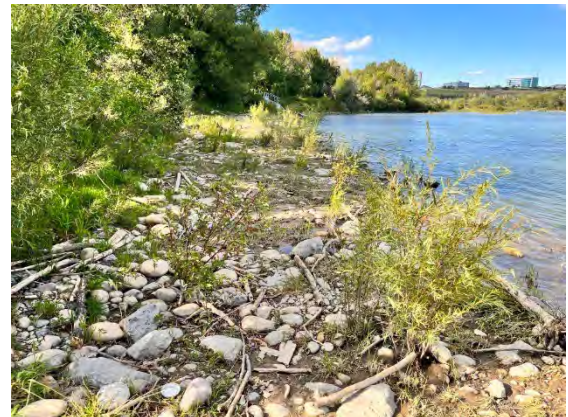
At several sites, river gravels were used to cover and/or infill riprap as shown in Photo 3-20 and Photo 3-21. This was observed to allow for better wildlife passage, accelerated ecological succession through colonization by herbaceous and emergent vegetation, and results in a more aesthetically pleasing bank. Further research is needed to confirm if void filling would result in an increase in erosive resistance and potentially result in a reduction in riprap size and avoid the need for a granular filter. Best practices for void fill construction are also needed.

**Photo 3-21: Example of void-filled riprap using river gravels and vegetated with live staking on the Bow River**

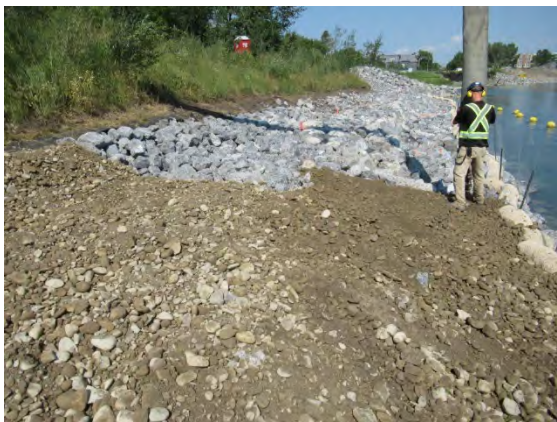
At the other two sites, growing medium (topsoil or pitrun) was used to void-fill the existing riprap and live staking or plugs were installed as vegetation. Topsoil installation is shown in Photo 3-51 and pitrun installation is shown in Photo 3-22. Despite the void-fill in the riprap, it remained challenging to establish woody vegetation, with high temperature fluctuations and low soil moisture as measured with in-situ soil moisture and temperature probes. Plugs were found to establish relatively well in the topsoil void-fill material, but there was high mortality in the live staking. It was thought that the void-fill may not have achieved the anticipated depth or have adequately filled in all the void spaces. This would have left some air voids in the fill that would result in air pruning of any roots that were growing from the live cuttings. Because of this, establishing live cuttings in the riprap has been very challenging, and shrub plugs have been planted to supplement the high mortality of the live cuttings. However, the herbaceous vegetation is establishing nicely at the site (Photo 3-23).

**Photo 3-22: Placing planting material in the riprap voids in May 2018**

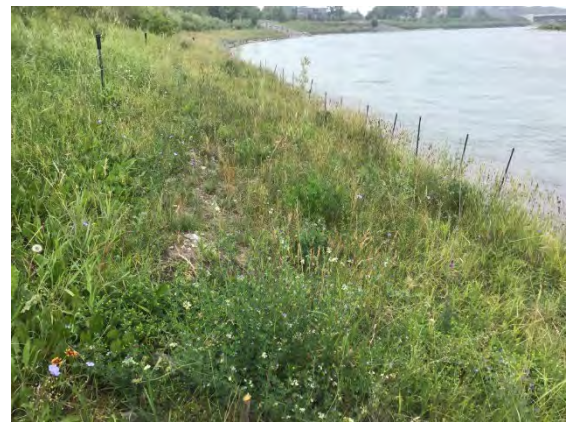
**Photo 3-23: High mortality of live cuttings but good herbaceous establishment in void-filled existing riprap installed on the Bow River in 2018 and assessed in 2019 and 2021**

While there is still room for improvement in developing an effective technique to vegetate existing riprap, filling voids as best as possible then focusing on establishing woody vegetation using plugs and seeding herbaceous vegetation appears to be a more appropriate approach given the observed challenging environment for establishing woody vegetation using container plants or live cuttings.

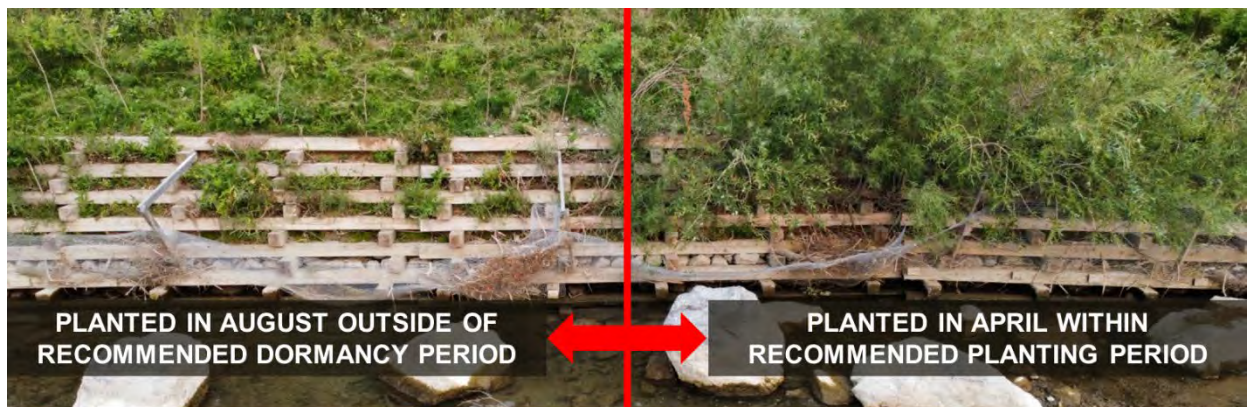
Poor vegetation growth and high mortality was observed at sites where special considerations were not made for bioengineering project construction schedule or appropriate stock selection. For example, live cuttings were installed at the site shown in Figure 3-3 during two different periods: 1) April 2017, and 2) August 2017. The spring installed cuttings have established quite well but there was high mortality in the August-installed cuttings. Live cuttings (and willow whips) should be installed when dormant – an appropriate schedule for the Calgary area is installation from October to the third week of June as shown in Figure 3-4.

**Figure 3-3: Result of Installing Live Cuttings Inside and Outside of Recommended Periods**

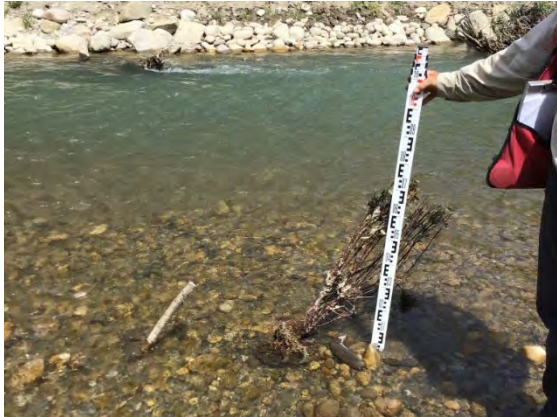
**Photo 3-28: Example of container plant in an eroded section of side channel on the Bow River in 2018 and assessed in 2019**

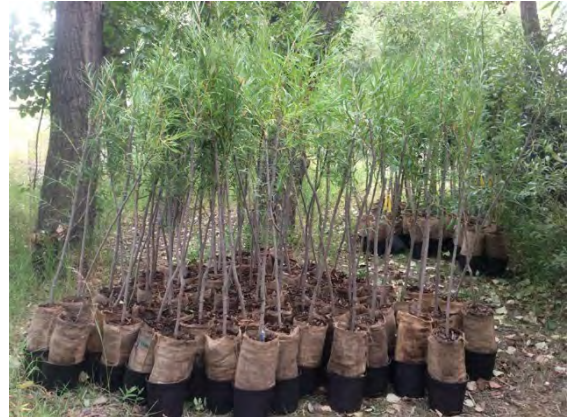
**Photo 3-29: Example of sandbar willow Tall Rooted Stakes (August 2018)**

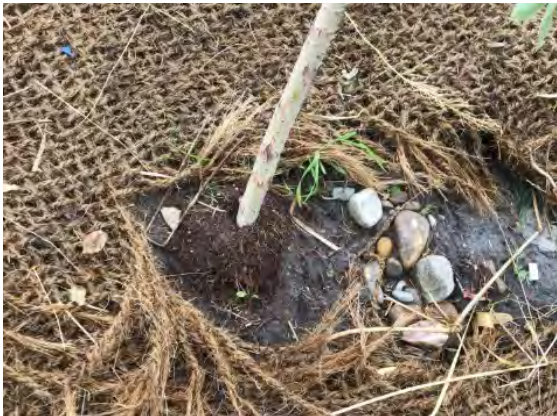
TRS have been used at three monitoring sites and have shown good establishment potential when installed properly (Photo 3-29). However, as shown in Photo 3-30, TRS at one site was observed to be installed incorrectly with only the root mass buried, leaving the bare stem and top growth exposed. This resulted in the TRS being unstable, easily eroded and toppled. An additional issue is that willow stems are not usually exposed to direct sunlight and there will likely be high mortality from sunburn and drying out because of the TRS installation method. An option to increase the use of container plants is to more regularly use hedge brush layers which is a combination of rooted stock and live cuttings within a brush layer (Photo 3-31).

**Photo 3-30: Example of TRS installed too shallow on West Nose Creek in 2021 and assessed in 2022**

As TRS become more popular, better guidance needs to be provided for appropriate design and installation. TRS when used for bioengineering applications, typically have a long, bare section of stem between the roots and top growth that is intended to allow for deep burial of the root mass and promote adventitious rooting along the stem. The top growth is then meant to be the only portion of the TRS that is left exposed. The entire stem would normally be buried approximately two-thirds of its length in a similar manner to the hedge brush layer technique. Where this is not achieved, failure of the technique is a risk.

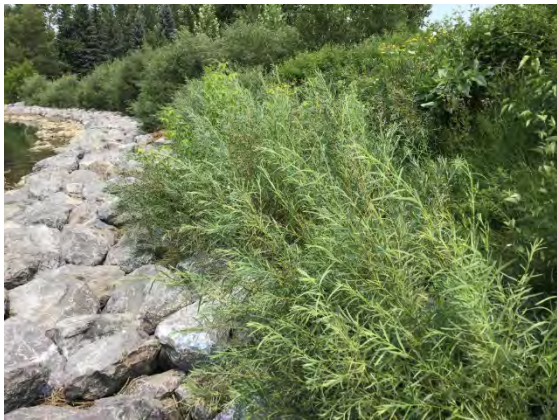
Some vegetated riprap sites have very good vegetation establishment despite the large amount of riprap placed at the site (Photo 3-33). For these sites, live cuttings were designed and installed at an angle and of a sufficient depth to access the water table, a practice sometimes referred to as installing live cuttings with 'wet toes' (Photo 3-34). Access to adequate soil moisture or groundwater is important for vegetation planted in thick riprap installations, since the riprap is known to retain heat and cause desiccation and high mortality of planted vegetation. Additionally, evidence of browsing and regrowth were also observed during the re-visits at these sites, indicating that the vegetation has developed significant root mass to withstand this type of disturbance.

**Photo 3-33: Example of good vegetation establishment at a vegetated riprap site installed on the Elbow River in 2015 and assessed in 2021**

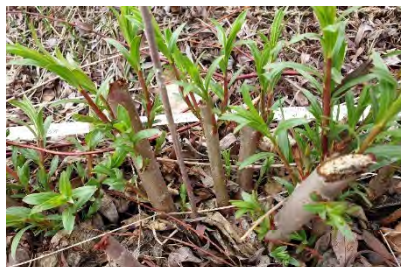
At one site on the Elbow River, the rodent fencing was in disrepair in the spring of 2020 when water levels on the Elbow River rose higher than average. The local beaver population took advantage of the damaged fence and browsed a  $\pm 27$  m section of the site (Photo 3-35). The fencing was repaired promptly and by mid-July browsing resulted in generally three to six (average of four) shoots growing (coppicing) from the cut stems (Photo 3-36). By September, the shoots had grown to an average height of 1.5 m creating a very dense vegetation cover (Photo 3-37). This vigorous growth is due to deeply planted cuttings and a well-established root system.

**Photo 3-36: 3 to 6 shoots growing from each browsed stem on May 25, 2020**

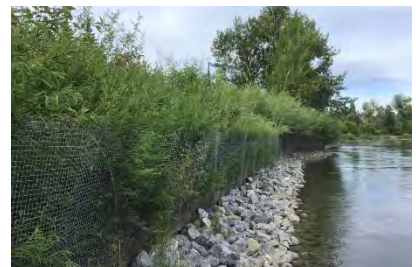
**Photo 3-37: Vegetation regrowth with average height of 1.5 m on July 21, 2020**

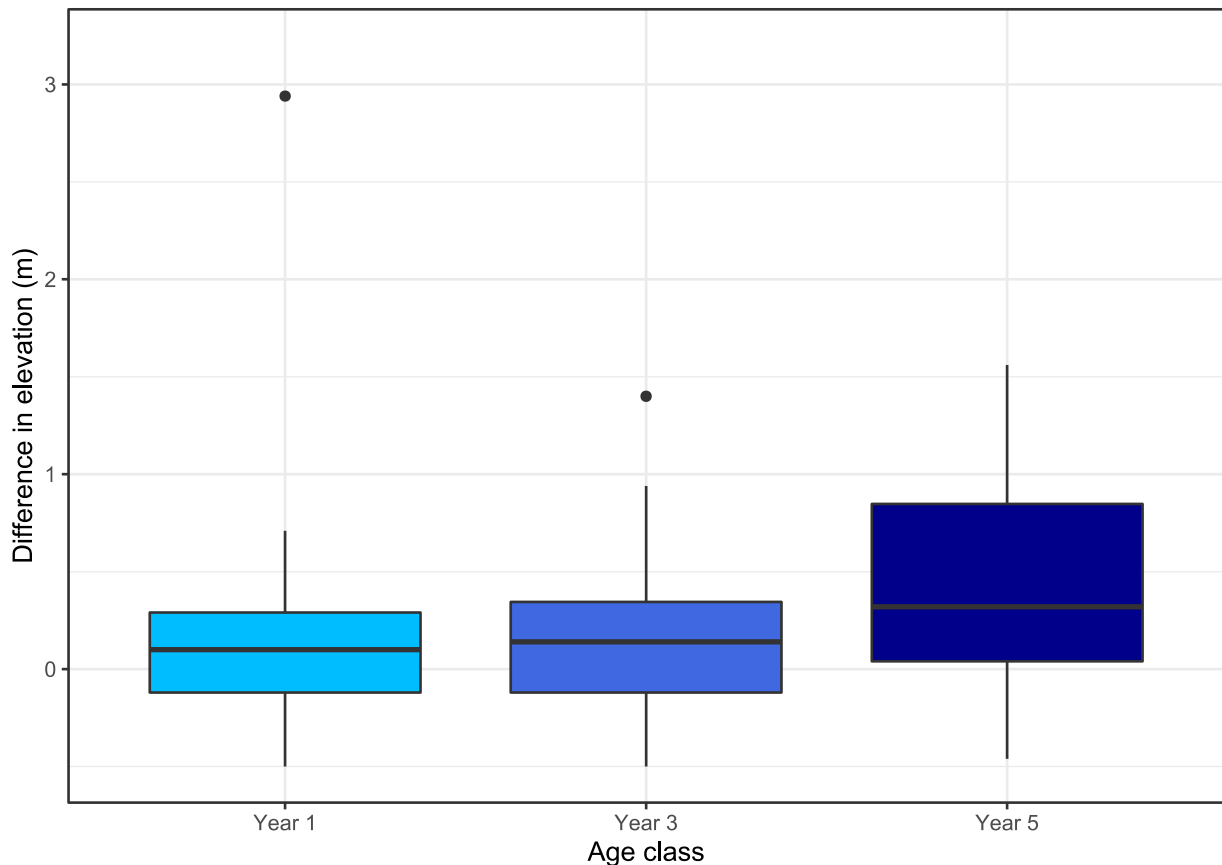
The results of comparing the surveyed difference in elevation between planted and existing woody vegetation by age class are shown in Figure 3-5. Median lowest elevation of planted vegetation for Year 1 age class sites more closely match the observed lowest elevation of native vegetation in comparison to the Year 3 and Year 5+ age class sites. These results appear to indicate that designers are changing their practice to lower the planted vegetation to meet the elevation of the existing vegetation. This suggests an improvement in the use of vegetation in bioengineering projects.

Figure 3-5: Difference in Elevation Between Planted & Existing Woody Vegetation<sup>2</sup>

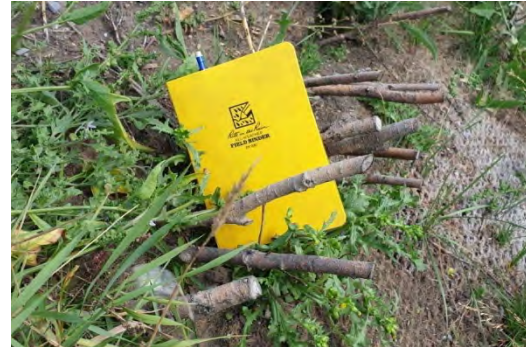
As described in Section 3.3.2 the bank effectiveness data revealed low to moderate survival (between 62% to 78% as shown in Table 3-20 below) for balsam poplar, hungry willow, and sandbar willow live cuttings. These species are the most commonly used species for bioengineering in Calgary and are known to have a very good ability to root from cuttings (AMEC, 2012; USDA NRCS, 1996; Gray & Sotir, 1996). Based on the RMP results, live cutting survivorship could be improved, particularly considering the overall Year 1 age class survivorship was 69% for all live cuttings assessed during the program and that the Year 1 age class survivorship would likely have been lower if vegetation survival data from failure sites was included in the analysis<sup>6</sup>. Photo 3-42 and Photo 3-43 show representative photographs of failure sites where survival was less than 25% for all species.

**Photo 3-43: Example of dead live cuttings installed on the Bow River in 2018 and assessed in 2019**

The reasons for this low to moderate survival need to be better understood to improve the design and implementation practices and overall bank project outcomes. However, following the best practices identified in Box 5 for live cutting installation and Box 6 for container plant installation and avoiding the common planting issues shown in Figure 3-6 will lead to some level of change in survival and long-term establishment. There may be other factors beyond those identified – particularly for balsam poplar where the appropriate best practices were used at some sites, but overall survival was still low. Overall, **it is important to keep in mind that key plant growth limiting factors within the Calgary region are primarily climate-related, including low precipitation and occurrence of Chinooks, or desiccating warm winter conditions. Vegetation design should be tailored appropriately by using best practices such as deeply buried techniques.**

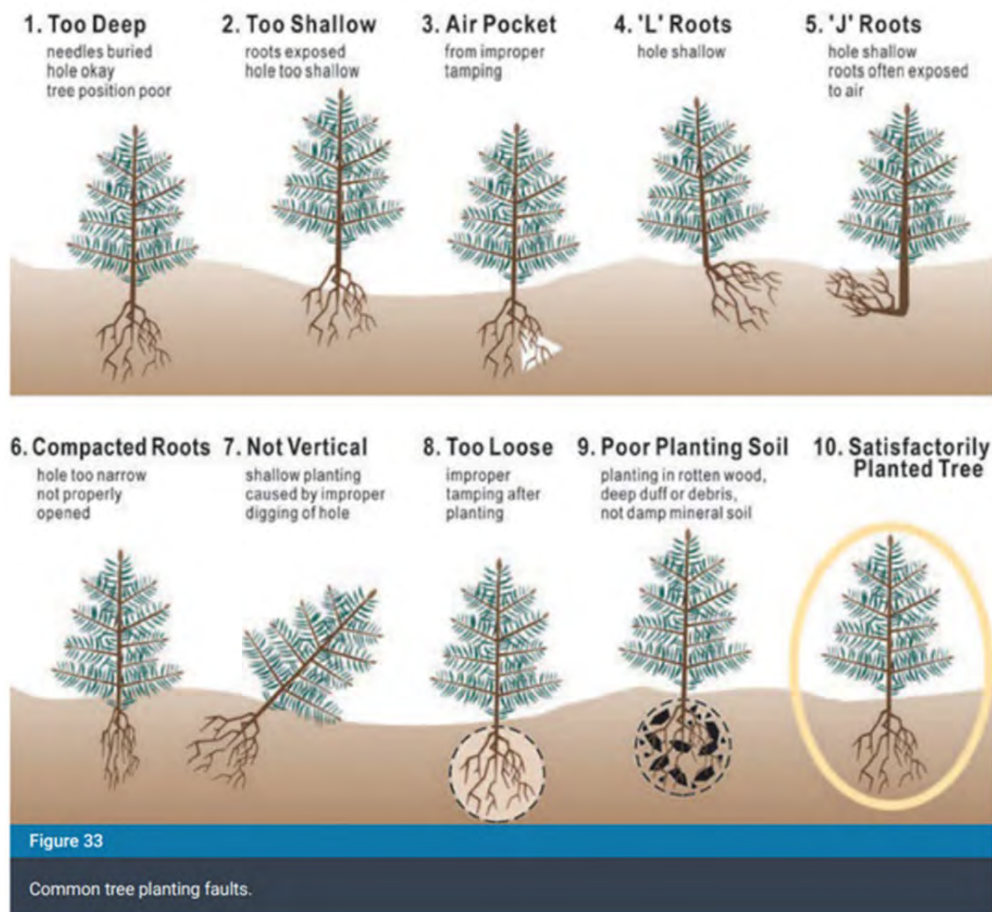
**Figure 3-6: Common Planting Issues**

- Ensure potted material is planted properly per Figure 3-6. Holes in the ground should be excavated such that the entire root ball is planted below ground with no exposed roots. The hole should be deep enough such that the plant crown is right at soil level. Additional topsoil (if needed) and soil amendment should be mixed with the native topsoil and placed in the hole around the roots. The soil around the stem should then be pressed firmly by hand or lightly by foot to remove air pockets and ensure good soil to root contact. When planting on sloped ground, a small compacted berm built in a half-circle shape should be constructed on the downhill side of the plant on the outside perimeters of the rooting zone in order to retain moisture and allow percolation into the root system.

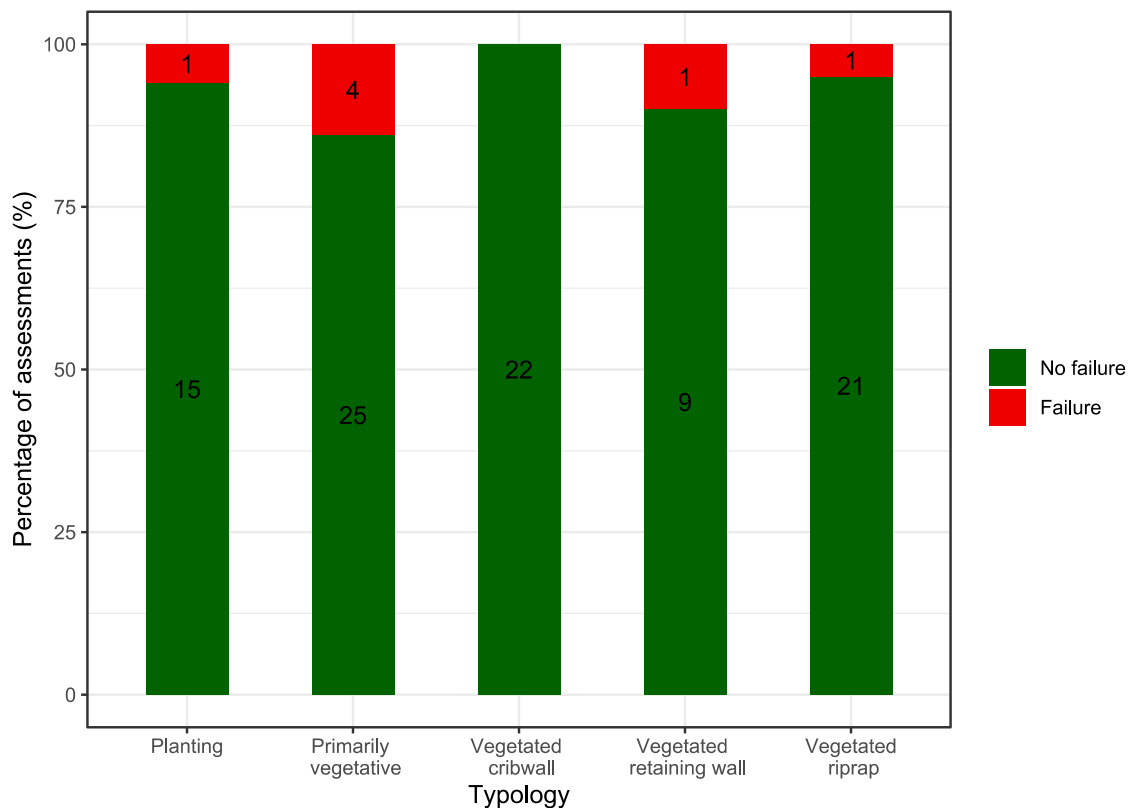
The RMP failure site protocol is described in Section 3.1.7. The most common reason for failure was due to vegetation survival of less than 25%. Other failures were due to the structures not being present or failing structurally. When site failures are assessed based on typology as shown in Figure 3-7, the highest failure rate and number of failure sites is Primarily Vegetative at 14% with four failure sites. The lowest failure rate is 0% for Vegetated Crib Wall; however, there was a Vegetated Crib Wall site that was assessed as a failure but was removed from the program due to a data collection issue.

Figure 3-7: Failure Sites by Typology <sup>7</sup>

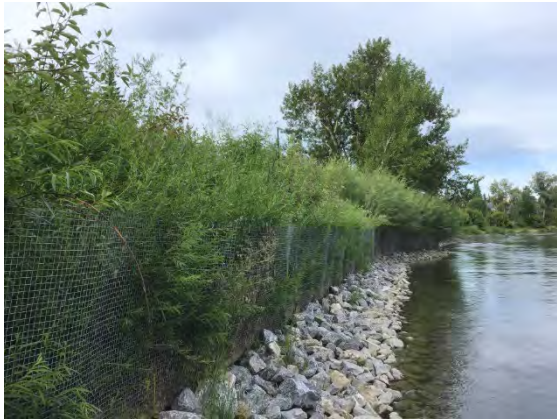
These results indicate fencing is a beneficial practice that should be considered for all riverbank bioengineering and riparian restoration projects when possible. An example of temporary browsing protection fencing is shown in Photo 3-60. Permanent, wooden fencing (Photo 3-61) is also a beneficial practice in that it provides a physical barrier for the public that allows for improved safety, improved natural regeneration of trees and shrubs, and reduced disturbance to the planted vegetation from compaction and trampling.

**Photo 3-60: Example of a temporary rodent fence installed around a bioengineering site on the Elbow River**

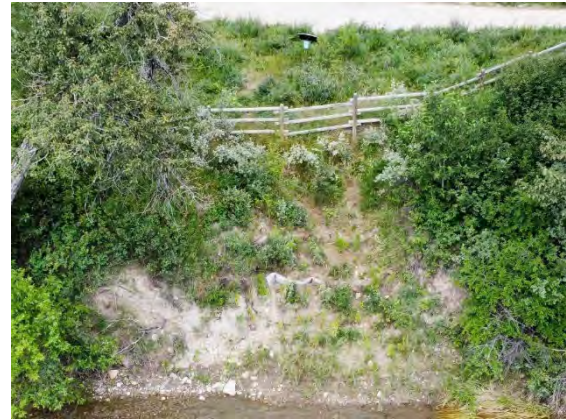
**Photo 3-61: Example of a permanent fence around a bioengineering site on the Elbow River**

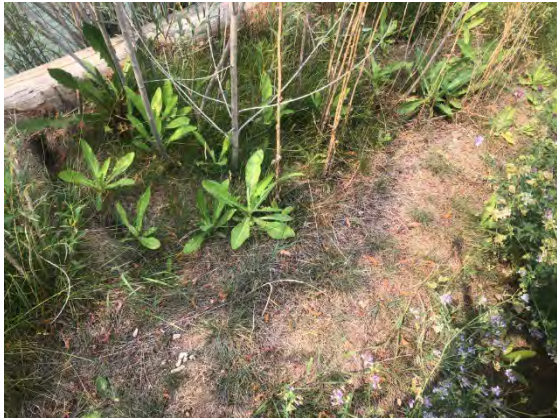
Soil compaction was also observed in the timber crib wall backfill, in areas of high public use, and at top of bank areas. Highly compacted backfill was commonly observed in timber crib wall sites with 10 out of 14 assessed sites (71%) having notable soil compaction (Photo 3-63). Areas of high public use were also observed to be compacted (Photo 3-64). However, the highest compaction for monitored sites was often measured at the top of bank in the riparian area or seeding zones where the staging/laydown area was located or where construction equipment travelled back and forth. Vegetation establishment was noted to be limited in the areas where soil was highly compacted.

Photo 3-63: Example of severe compaction in the timber crib wall backfill at a site on the Bow River

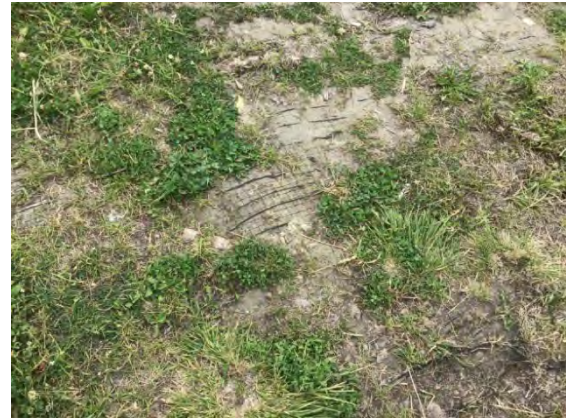
Photo 3-64: Example of severe compaction at a site on the Bow River due to public use

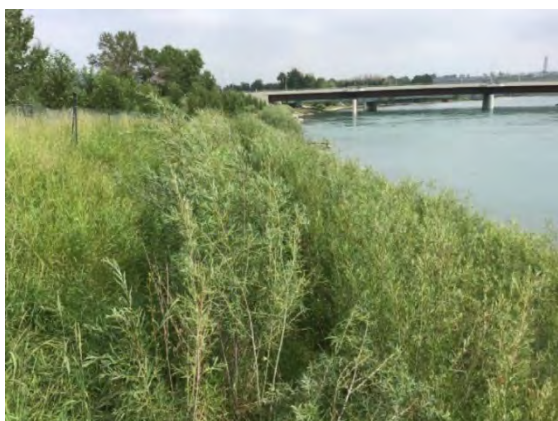
While brush layers (example shown in Photo 3-65) are the fourth highest performing technique overall based on vegetation establishment parameters, they are also often used in vegetated timber crib walls and vegetated retaining walls that ranked higher in this analysis. Thus, they are considered a robust, deeply buried bioengineering technique with a history of good establishment that should be considered for bioengineering projects in Calgary when appropriate. However, brush layers do require heavy equipment and excavation into the bank which may not be preferred for all sites.

**Photo 3-65: Example of a brush layer technique installed on the Bow River in 2018 and assessed in 2019 and 2021**

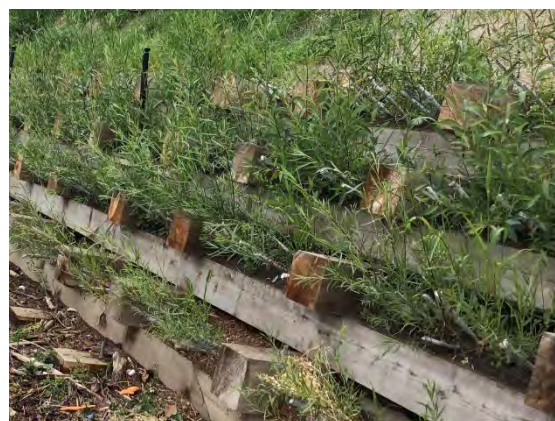
The vegetated crib wall technique ranked second overall (example shown in **Photo 3-8**). While all other vegetation growth parameters were high, Year 1 age class survival for vegetated crib wall is low (see Table 3-21). Note that while vegetation growth in timber crib walls was found to be doing well, timber crib walls require high levels of design, regulatory and construction efforts. The life cycle of the structure should also be considered during design so that the final arrangement of the bank is anticipated once the timber decomposes and the vegetation is intended to take over the role of bank stabilization. Additional timber crib wall considerations are provided in Section 3.3.1 General Results, Structure Design.

**Photo 3-66: Example of a vegetated timber crib wall technique installed on the Bow River in 2019 and assessed in 2020**

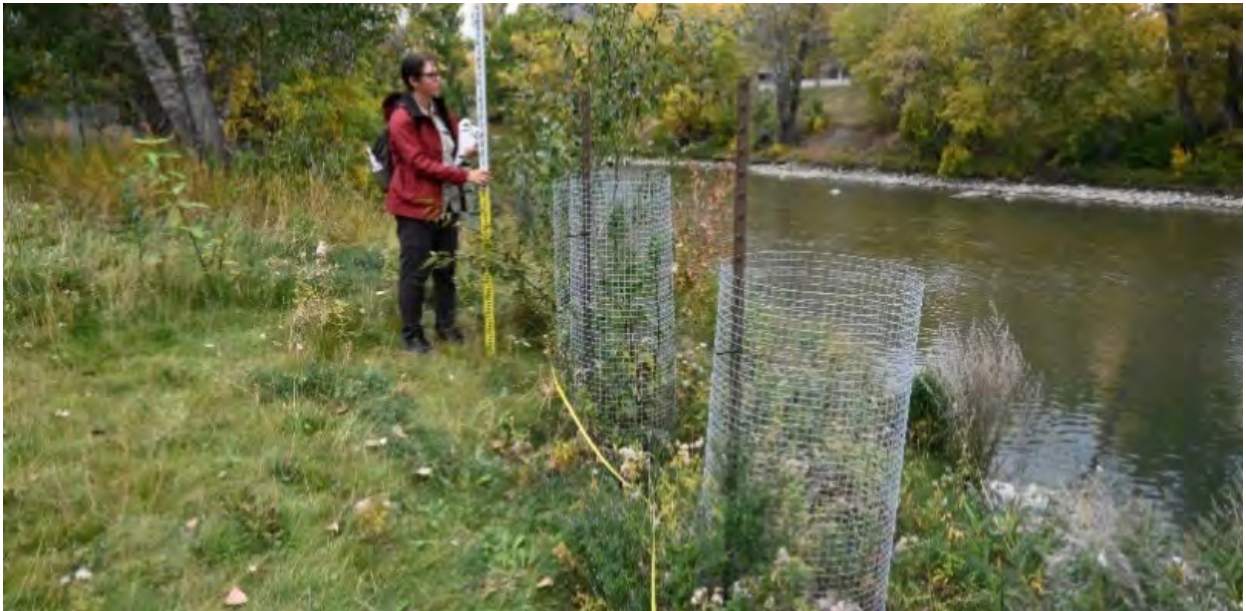
**Photo 4-1: Riparian Effectiveness Monitoring Site Example: Ramsay Along Elbow River**

*Project constructed in 2017 and monitored under the riparian effectiveness component in 2018, 2020 and 2022*

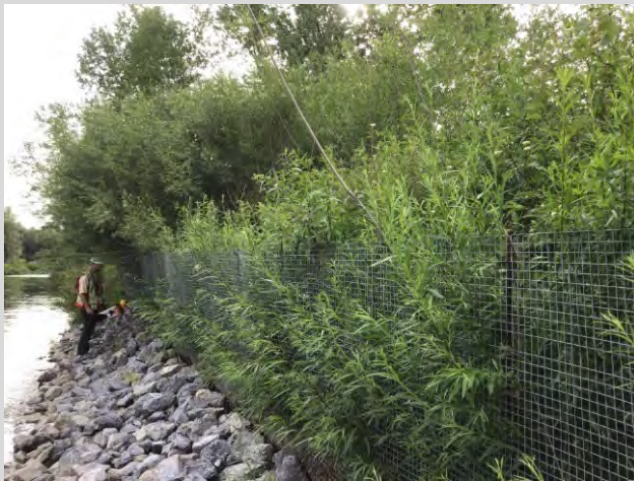
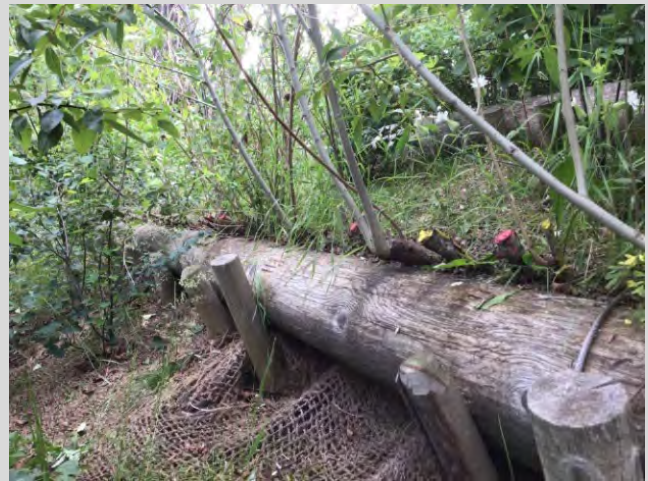
**Description:** At the Riverdale Avenue Retaining Wall Replacement Phase 2 – Downstream site, the design featured live grating and brush layers, with a rock toe below to prevent toe erosion. Some of the highlights of the site include: brush layers composed of deeply planted live cuttings; a high density of cuttings per linear meter that are providing a large root mass to assist in bank stabilization; substantial top growth that is shading invasive weeds over the site; shade tolerant rooted species planted between the brush layer rows; soil amendment used on the live cuttings and rooted trees and shrubs; native grasses seeded at prescribed application rate and applied under the coir erosion control matting; large logs used as part of the live grating that support bank stability and help to retain soil moisture; and, rock toe to prevent toe scour. Additionally, good quality plant materials, low levels of soil compaction, good installation that were in accordance with the design, and good maintenance practices and scheduling led to high ratings for this site.

**Rating:** The site was rated the highest rated site in 2018 (Year 1 post-construction) where the rating was 92/100. This site was also assessed in 2020 (Year 3 post-construction) as the highest rated site and received a rating of 87/100 (Good).

**Photo 6-1: Riverdale Avenue Retaining Wall Replacement Phase 2 – Downstream in 2020**

Looking downstream in the photo to the left. The photo on the right shows a close-up of the live grating structure, the brush layer above, and the shade tolerant container plants between the live grating logs.

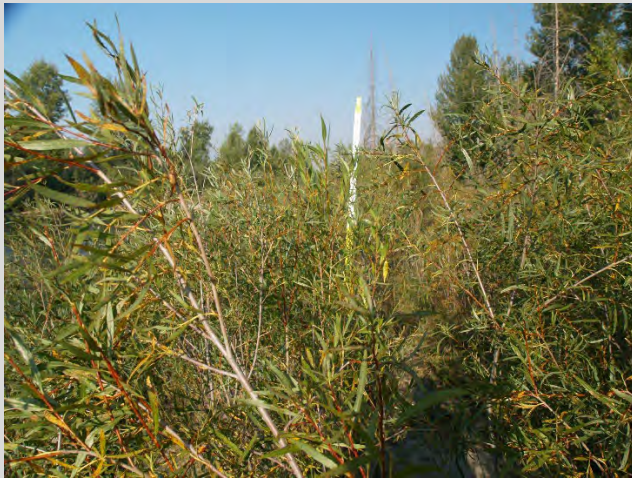
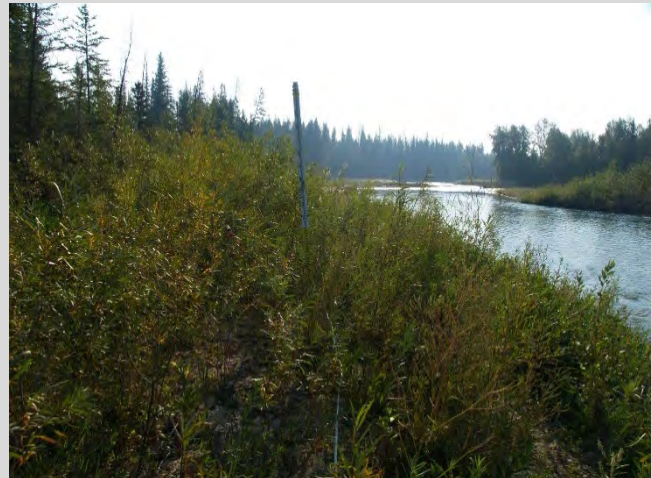
**Description:** Success factors included: appropriate timing of planting; appropriate species selection (native riparian shrubs and shrubs); appropriate planting locations; appropriate material type selection (plugs/potted shrubs/trees); good planting quality; plant material supplied appeared to be healthy and vigorous; although no irrigation occurred, shrubs were planted close to the river where there is a high water table; and overall high survival rate of shrubs and trees due to the factors listed above; and sufficient background information to conduct monitoring program.

**Rating:** 79 / 100 (Good)

**Photo 6-2: Griffiths Woods Park along the Elbow River in 2018**

The photo on the left shows the view west from the end (30 m) of the pin-point transect, whereas the photo on the right shows the view east from the start (0 m) of the same pin-point transect.
